CONTESSA 32 CLASS ASSOCIATION TECHNICAL PAPER

REPLACEMENT EXHAUST FOR PERKINS PERAMA

Technical Paper Name	Replacement Exhaust for Perkins Perama
Original Contributor	Conor Owens – “Sealion”
Edited by	George Isted
Date of Original Creation	December 2009

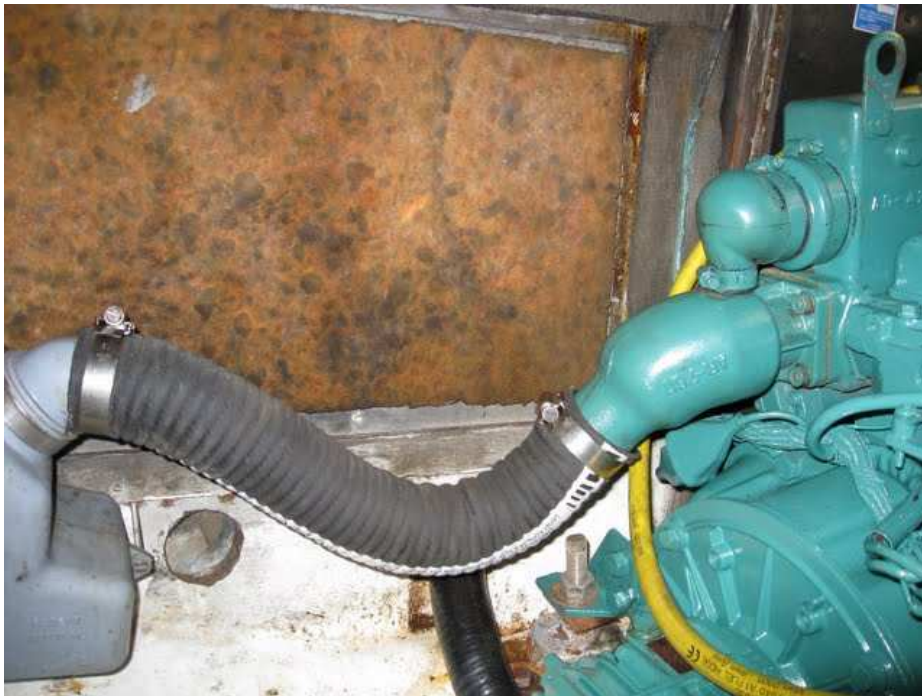
This is the old configuration. Not much fall from the mixing elbow to the water lock. I think the waterlock used to be slightly lower but only loosely affixed with cable ties, before being bolted to the cockpit locker side

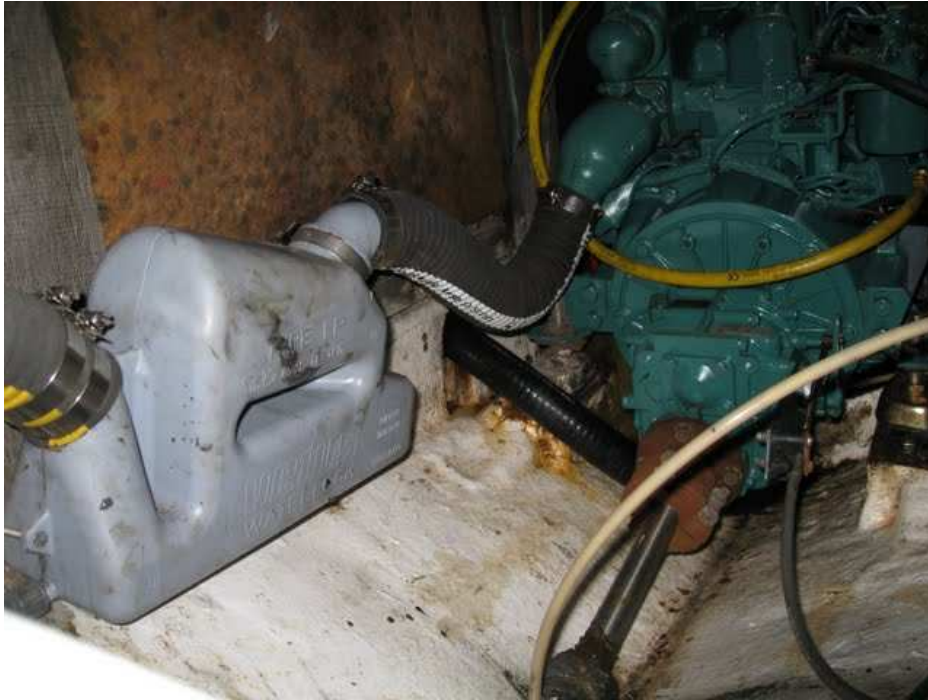
Another view of the old configuration. The waterlock capacity was 4.5 litres. When I went to remove it it was full almost to the top - probably about 4 litres. I think that this contributed to high back pressure and made it difficult to start

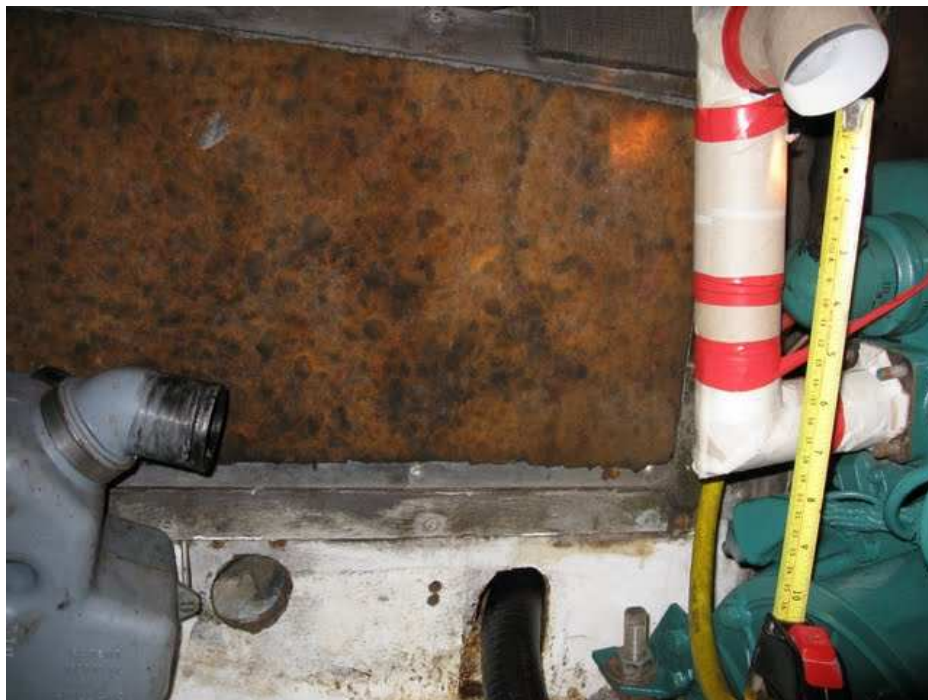
The prototype for the replacement exhaust riser. I want to raise it at least 6 inches - managed to get about 8 to close under the cockpit floor.

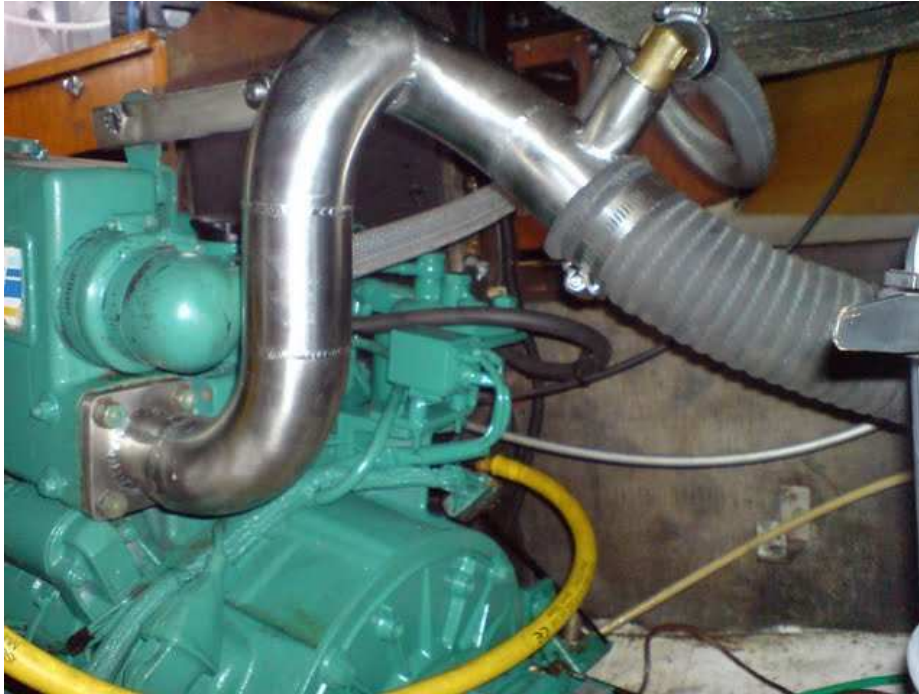
The new riser in place. The engineers tack welded it first but it was right first time. The new piece is lighter than the old cast elbow, but is a longer lever arm. To support it I used a short bar across to the engine lifting lug

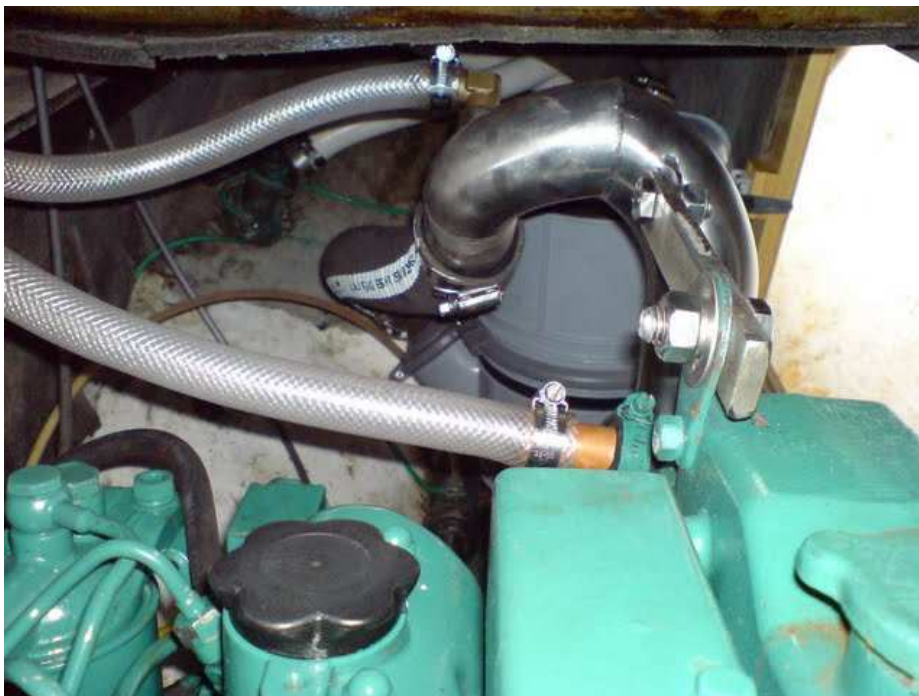
Behind the engine the gray cylinder is the new Vetus NLP water lock. It has 10 litre capacity in two chambers - 1 above the other

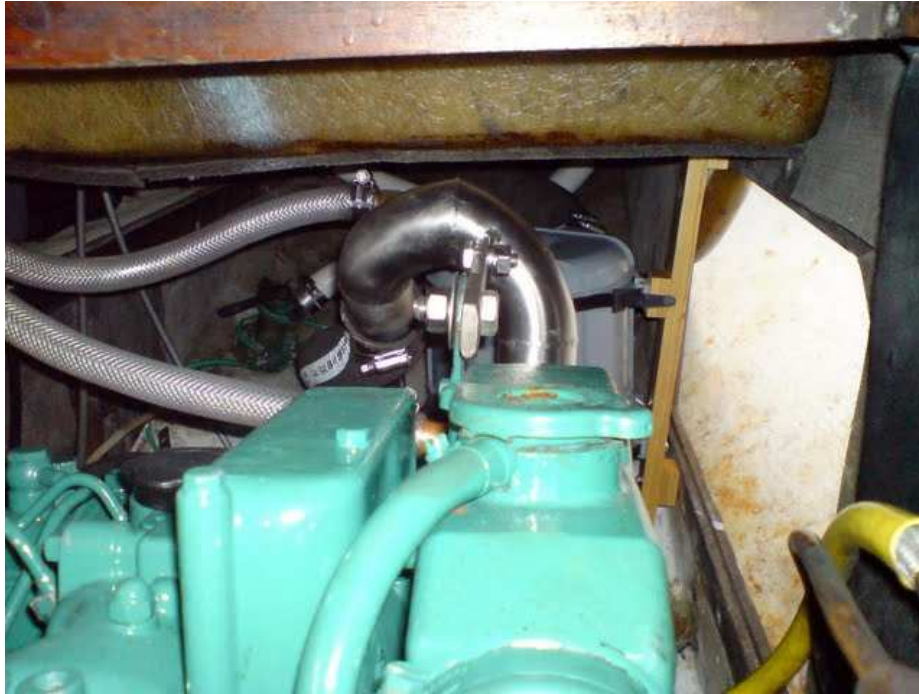
The waterlock is secured to a piece of wood bolted to the side of the cockpit locker. It also sits on a small plywood shelf expoxied onto the hull. The base is about 2 inches lower than the old waterlock

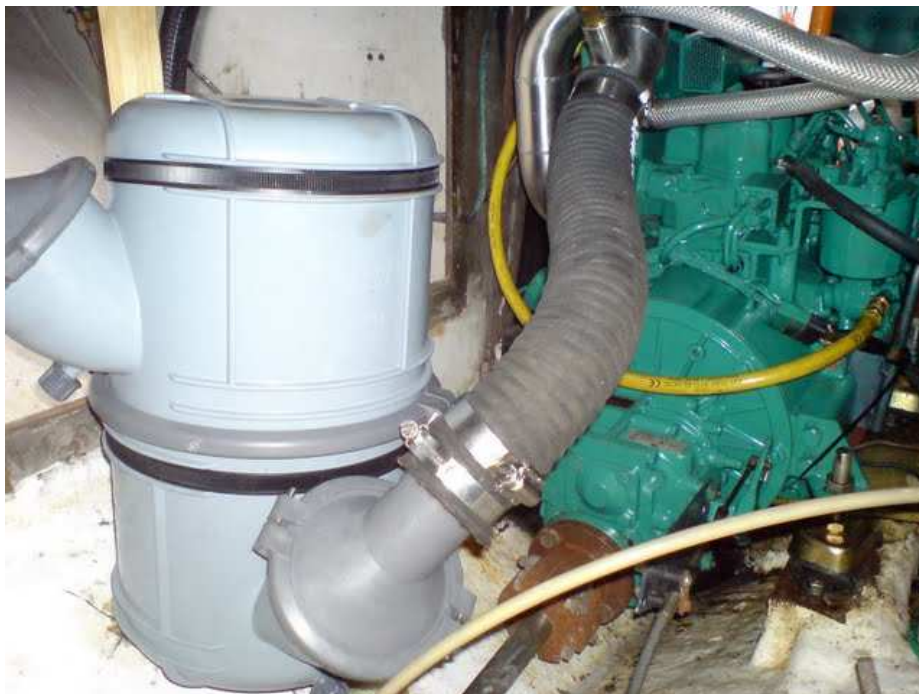
The waterlock. After use the lower part is left with about 2.5 litres of water and there is about 0.5 in the upper part. Each part has a drain plug. Since this picture I've fitted a hose to the lower drain which runs to the bilge. It can be accessed under the cabin floor to remove the plug and drain the waterlock

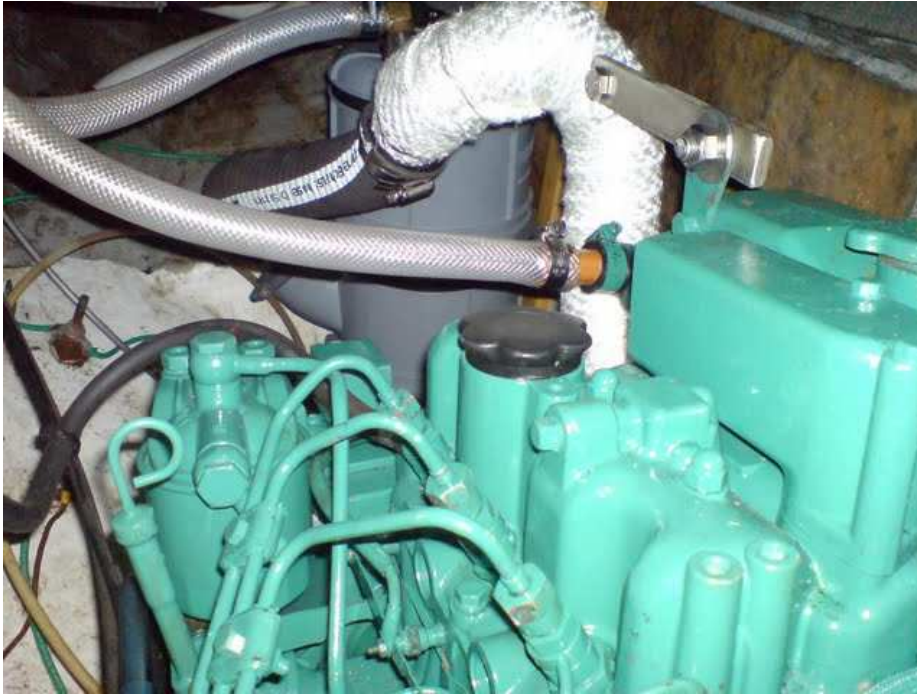
The new exhaust riser with lagging. Still some jobs to do - need a slightly longer water hose and a 2nd hose clip on the riser/pipe join. The engine now starts much more quickly and hopefully won't get any water into it again!

Note – Before launching a slightly longer and more flexible exhaust hose was fitted from the engine to the bottom of the Vetus waterlock, this allowed the input to be further around to the port side such that when heeled to starboard less water is able to run back up the hose.
